Most Endangered Properties 2006

Bannister Log Dog Trot House, Bannister Road, near Coolidge

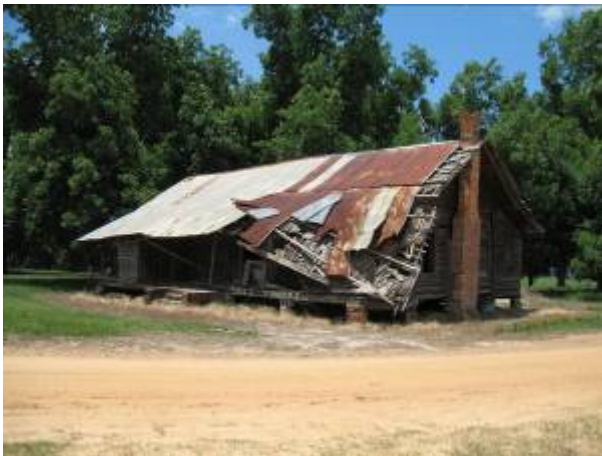
Left: The Bannister Log Dog Trot is a prime example of a house of its type. The porch roof obscures the beauty of its form, but the structure of the main part is intact.

Solution: Landmarks urges the owner to consider stabilizing or rehabilitating the house. If that is not feasible, Landmarks recommends that the house be sold and moved to a location where it can be preserved.

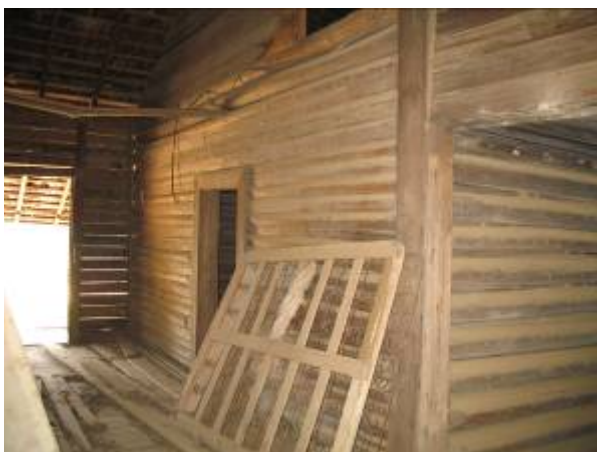
Left: The dog trot open passageway in the center of the house shows the construction technique of round and hewn logs with chinking.
